**EXHIBIT “1”**

10710 Hobbiton Ave  
Las Vegas, NV 89135

**5 Star Home Inspection, LLC**

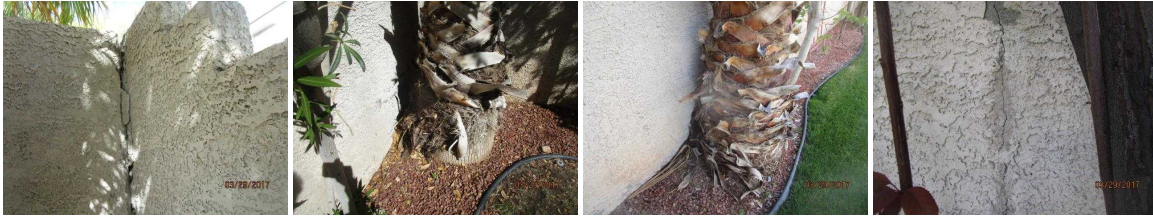
Retaining Walls: Block Numerous palm trees are too close to the walls, There are some cracked blocks.

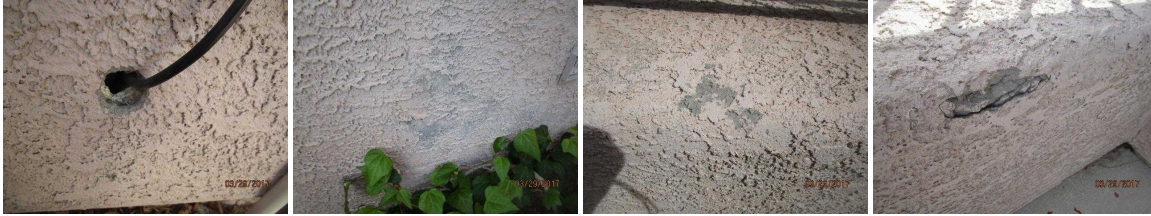
Cosmetic Type: Stucco **Several dings**

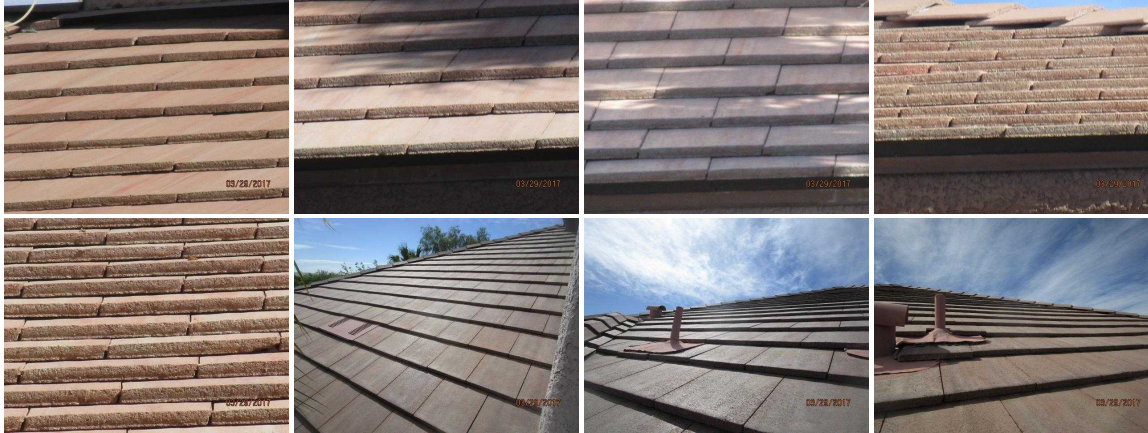
### Main Roof Surface

Acceptable Unable to Inspect: 30%, did not walk on the tile roof Since "Home Inspections" are visual inspections and are not certifications or warranties, We highly recommend a roofing inspection & certification from a licensed roofing contractor.

Defective Material: Cement tile **The lower front tiles at the flashing are all loose and slipping down, some are broken.**

**A qualified roofing contractor is recommended to evaluate and estimate repairs**

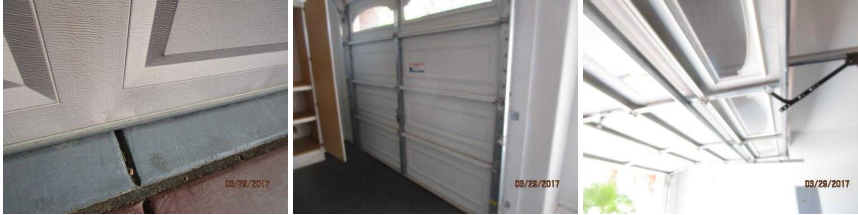
Cosmetic Garage Doors: Aluminum x 2 **Several small dents.**

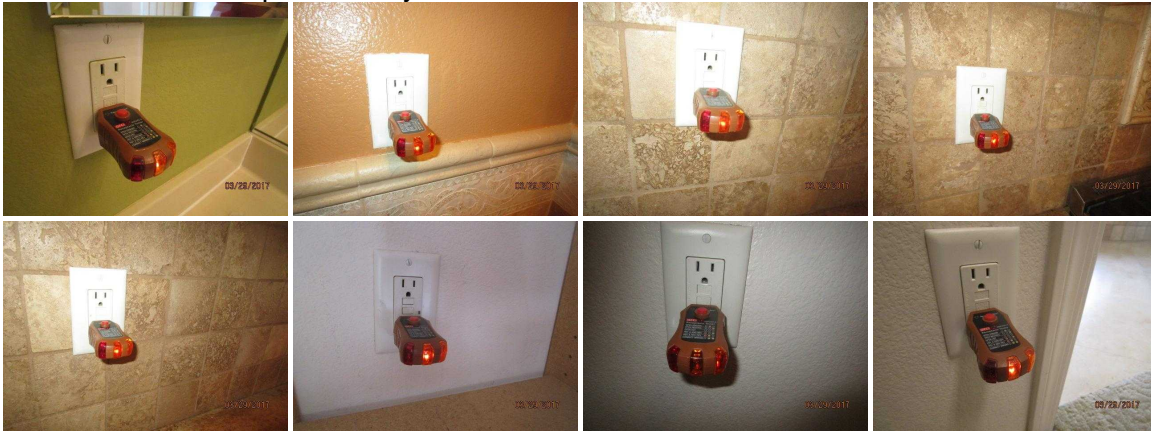
Acceptable Breakers: Copper

Acceptable GFCI: At GFCI receptacles only

Is the panel bonded? Yes

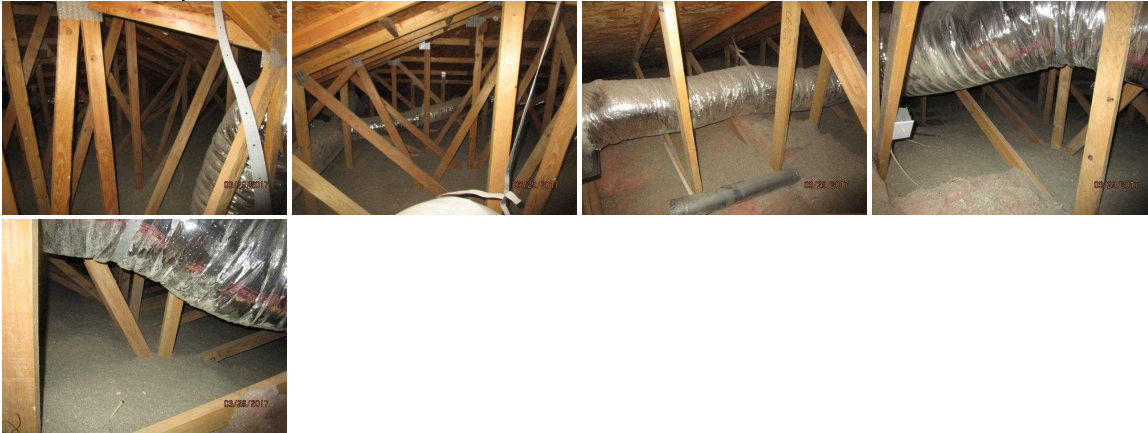
### Upper Hall Attic

Acceptable	Unable to Inspect: 20%
Acceptable	Roof Framing: 2x10 Truss
Acceptable	Sheathing: Plywood
Acceptable	Ventilation: Gable, roof and soffit vents
Acceptable	Insulation: Fiberglass
Acceptable	Insulation Depth: 10"
Acceptable	Wiring/Lighting: 110 VAC
Acceptable	Bathroom Fan Venting: Electric fan

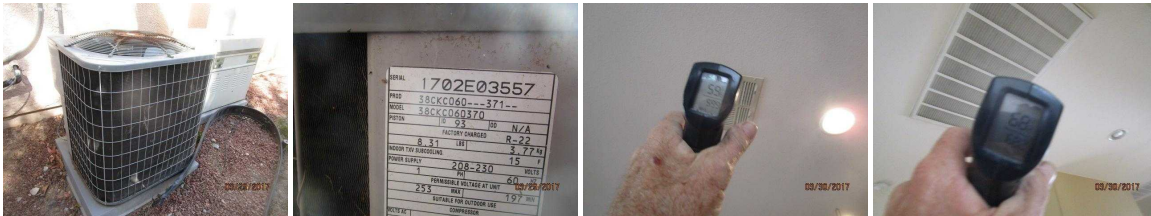
### Exterior AC System

Acceptable A/C System Operation: Functional  
 Acceptable Condensate Removal: PVC  
 Acceptable Exterior Unit: Pad mounted

Manufacturer: Carrier  
 Model Number: 38CKC060370 Serial Number: 1702E03557  
 Area Served: 1st floor Approximate Age: UNKnown  
 Fuel Type: 120-240 VAC Temperature Differential: 58 Degrees, Diff 74  
 Type: Central A/C Capacity: 5 Ton  
 Acceptable Visible Coil: Copper core with aluminum fins  
 Acceptable Refrigerant Lines: High pressure  
 Acceptable Electrical Disconnect: Breaker disconnect

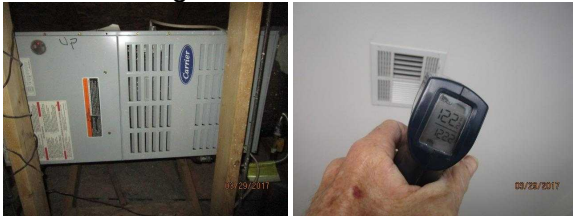
Acceptable Flue Pipe: Double wall  
 Acceptable Controls: Limit switch  
 Attic Heating System  
 Acceptable Heating System Operation: Adequate  
 Manufacturer: Carrier  
 Type: Forced air Capacity: 60,000 BTU  
 Area Served: 2nd Floor Approximate Age: UNknown  
 Fuel Type: Natural gas  
 Acceptable Heat Exchanger: 4 Burner

Unable to Inspect: 40%, Not an HVAC contractor, only visible inspection from the open door and exchangers.

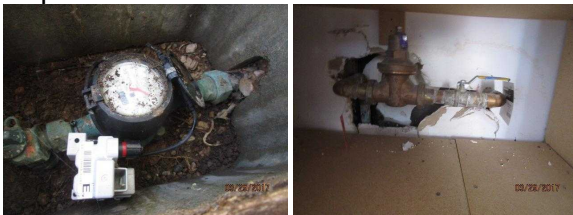
Acceptable Service Line: Cast iron  
 Acceptable Main Water Shutoff: Front of house The main valve was not moving or spinning at the time of the inspection.

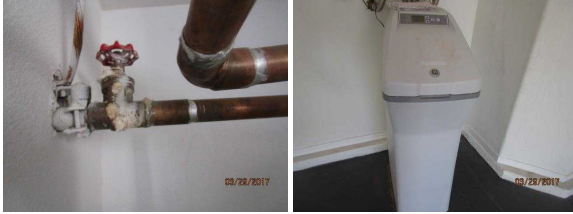
Water Heater Operation: Adequate Some corrosion around the shut off valve.  
We do not test any soft Water system

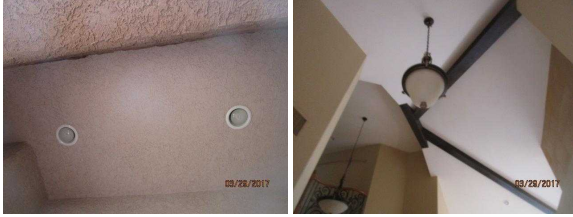
Electrical: 110 VAC The front porch and entry lights do not turn on. May be burned out bulbs.

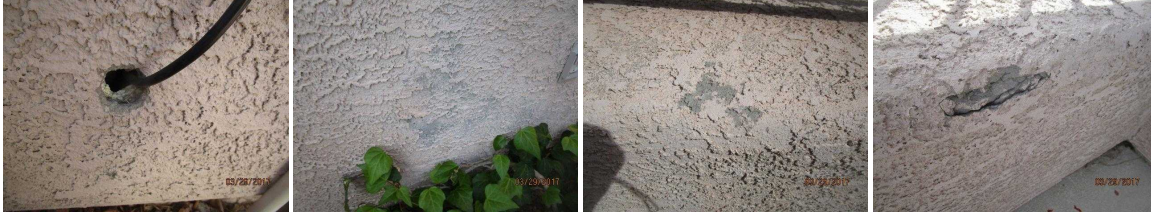
1. Main Exterior Surface Type: Stucco [Several dings](#)

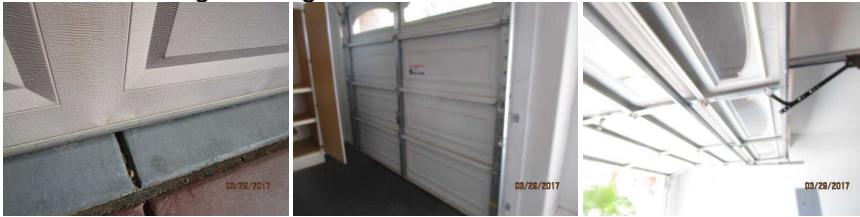
3. Attached Garage Garage Doors: Aluminum x 2 [Several small dents.](#)

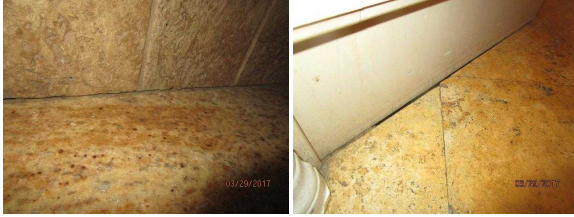
8. Main Kitchen Counter Tops: Granite [Caulking is needed at the back splash](#)

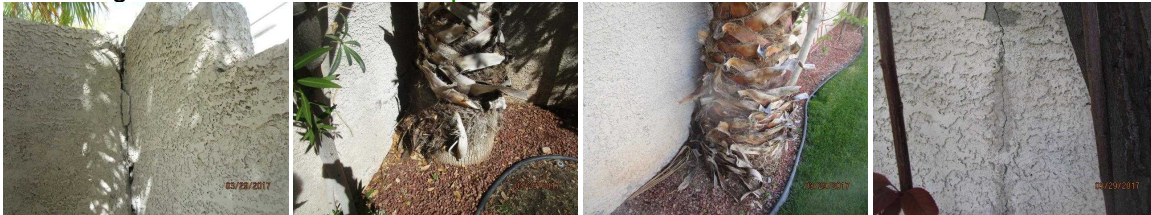
2. Retaining Walls: Block Numerous palm trees are too close to the walls, There are some cracked blocks.

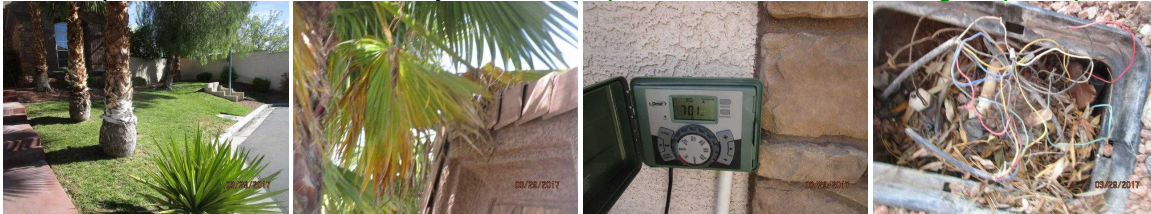
3. Lawn Sprinklers: Front and back yard 1 front sprinkler head shoots straight up, Replace.

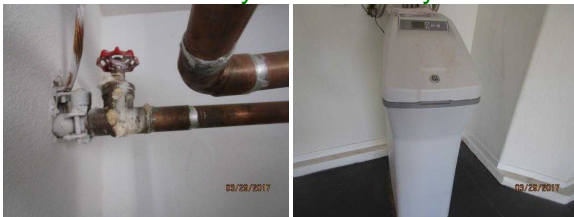
5. Garage Water Heater Water Heater Operation: Adequate Some corrosion around the shut off valve.  
We do not test any soft Water system

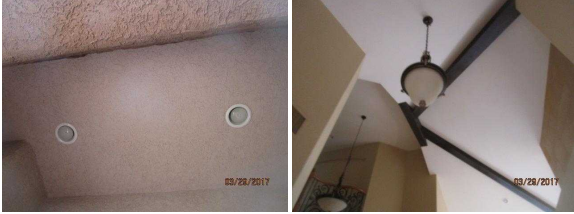
11. Living Room Living Space Electrical: 110 VAC The front porch and entry lights do not turn on. May be burned out bulbs.

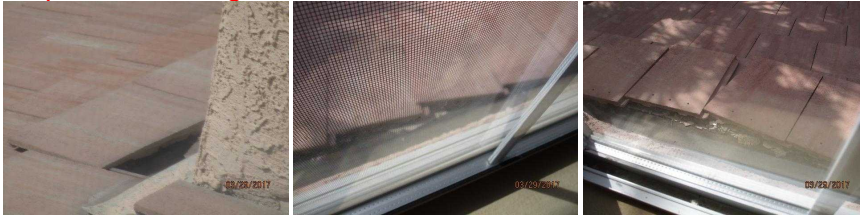
1. Main Roof Surface Material: Cement tile **The lower front tiles at the flashing are all loose and slipping down, some are broken.**  
**A qualified roofing contractor is recommended to evaluate and estimate repairs**

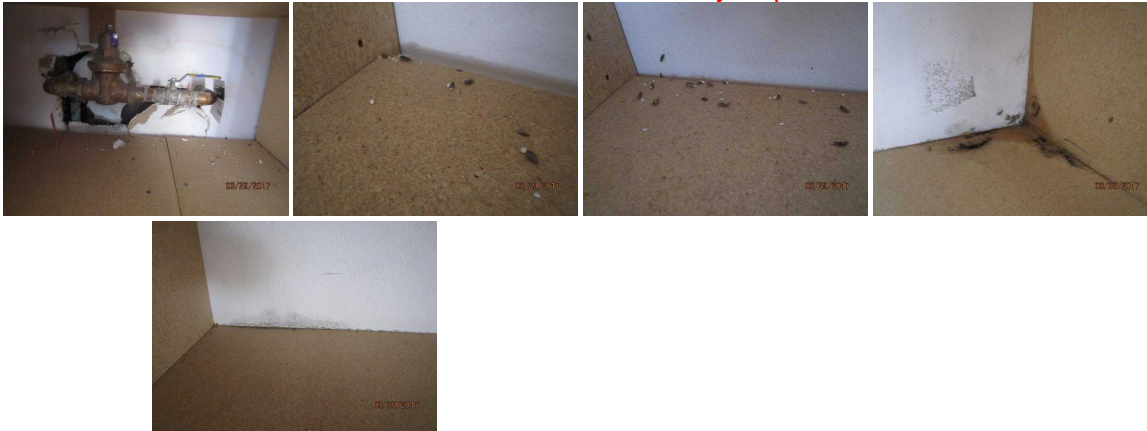
2. Attached Garage Walls: Texture paint **There is a drywall hole at the water shut off valve that needs to be repaired.**  
**There is also some black substance on the drywall behind the cabinets, only partially visible.**  
**There is also some rodent droppings inside of 1 of the cabinets, Recommend a licensed pest control .**  
**Recommend an environmental test and remediation by a qualified remediation contractor.**

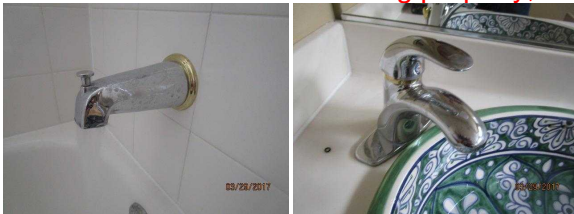
3. Full Lower Bath Bathroom Faucets/Traps: Moen fixtures with a PVC trap **The sink faucet has the hot & cold operation reversed.**  
**Shower diverter not functioning properly, all water is not flowing to showerhead**

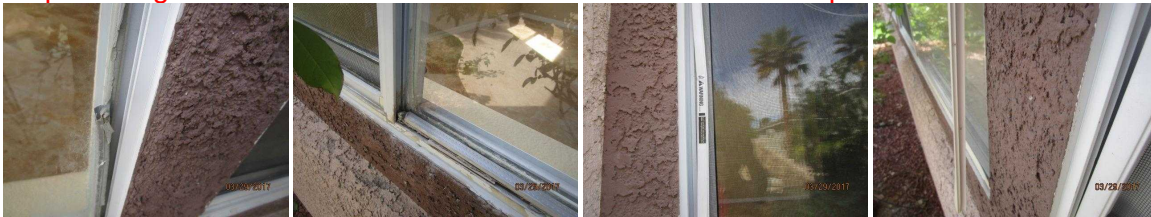
5. Living Room Living Space Windows: Aluminum slider **1 window is heavily damaged and the exterior pane is missing.**  
**1 other window has some of the exterior plastic moulding that is loose.**  
**A qualified glazier is recommended to evaluate and estimate repairs**

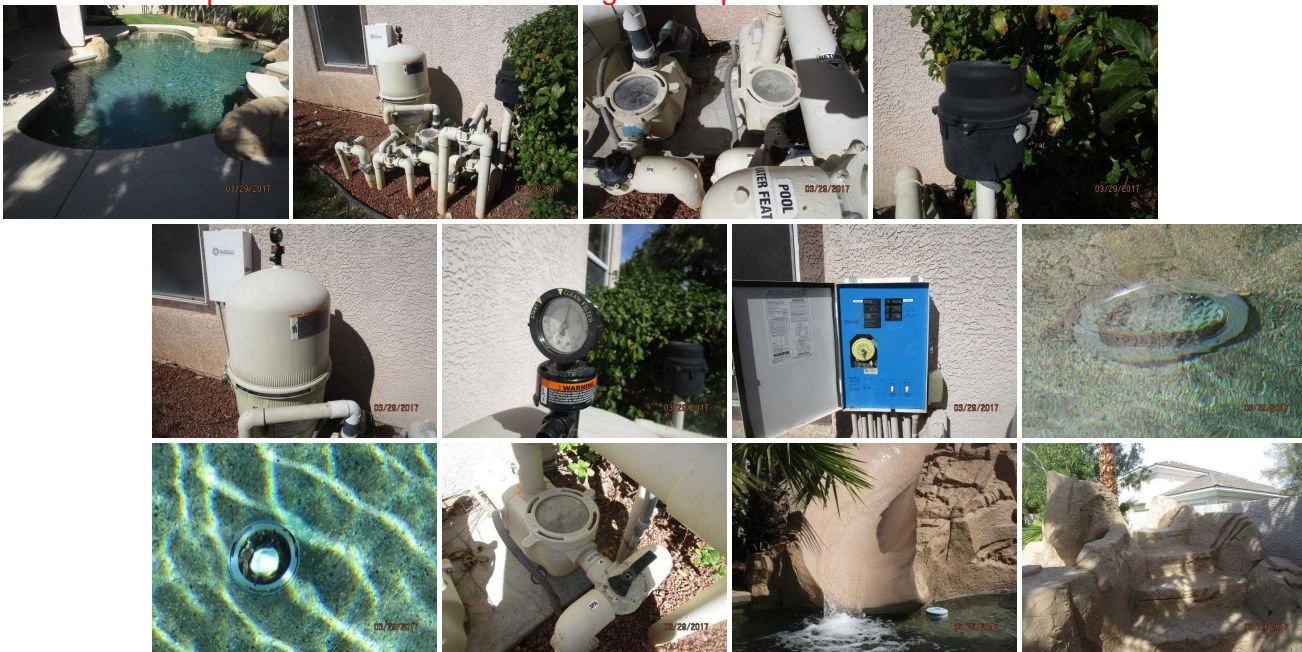
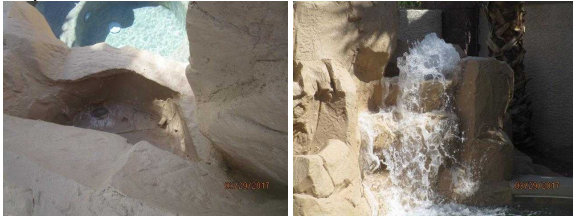
7. Behind home Swimming Pool Type: Pebble Tech Finish **The pump for the water falls and the slide, pumps way too much water. The water flows over the area and also down the back side stairs.**  
**The pool light does work, but appears to be 1/2 full of water.**  
**Recommend a pool contractor check out and give an opinion as to what can be done.**
